Field Survey of the 27 February 2010 Tsunami in Chile Maule and Biobío Regions, Juan Fernández Archipelago and Rapa Nui

Abstract

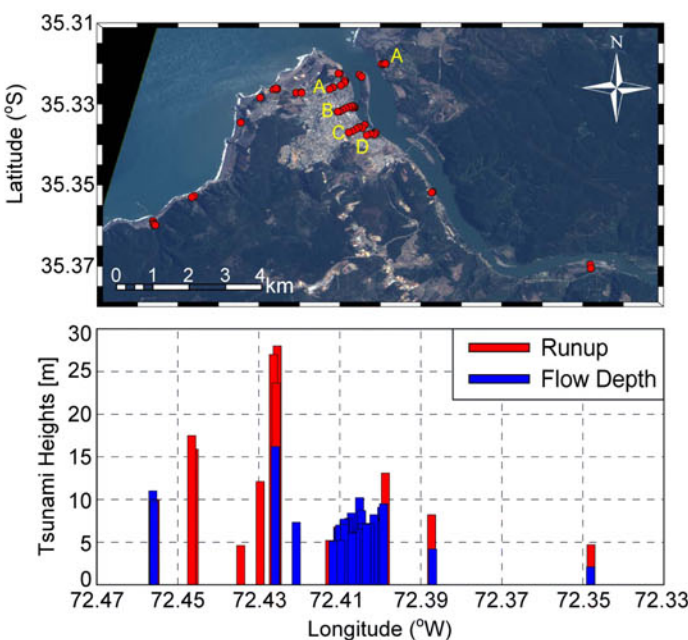
The tsunami impact peaked with a localized maximum runup of 28 m on a steep slope within less than 2 km of the river mouth at Constitución (Figure 3).

Figure 3. Measured tsunami flow depths and runup heights at Constitución and along the Maule River.

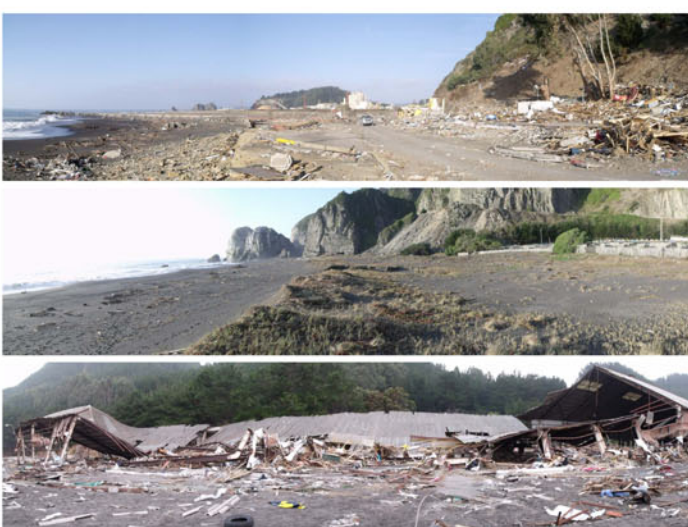
However only 1.2 km south along an open stretch of coastline with a wide beach and a low lying campground with wooden huts at 5 m terrain elevation the tsunami only reach 4 m (Figure 4).

Figure 4. Significant variation of tsunami impact along 5 km of open coastline southwest of the Maule River mouth: (a) Max. runup 28 m, (b) Intact campground with 4 m runup, (c) Destroyed warehouse.

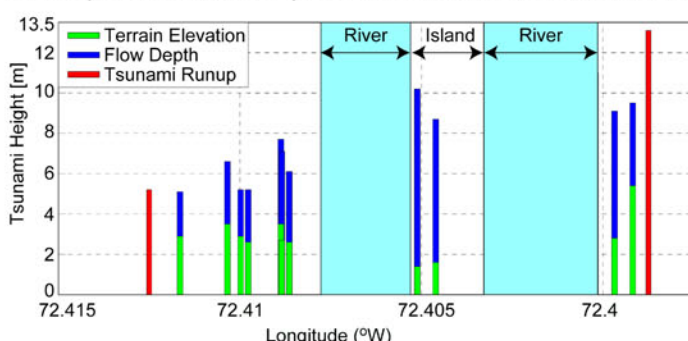
Inside the estuary a unique river-crossing transect (A-A) was measured (Figure 5). The island in the middle of the river was completely submerged by the tsunami with 10 m flow depth. The 200 campers on the island had no chance.

Figure 5. Measured tsunami flow depths and runup heights at Constitución across the Maule River along transect A-A in Figure 3.

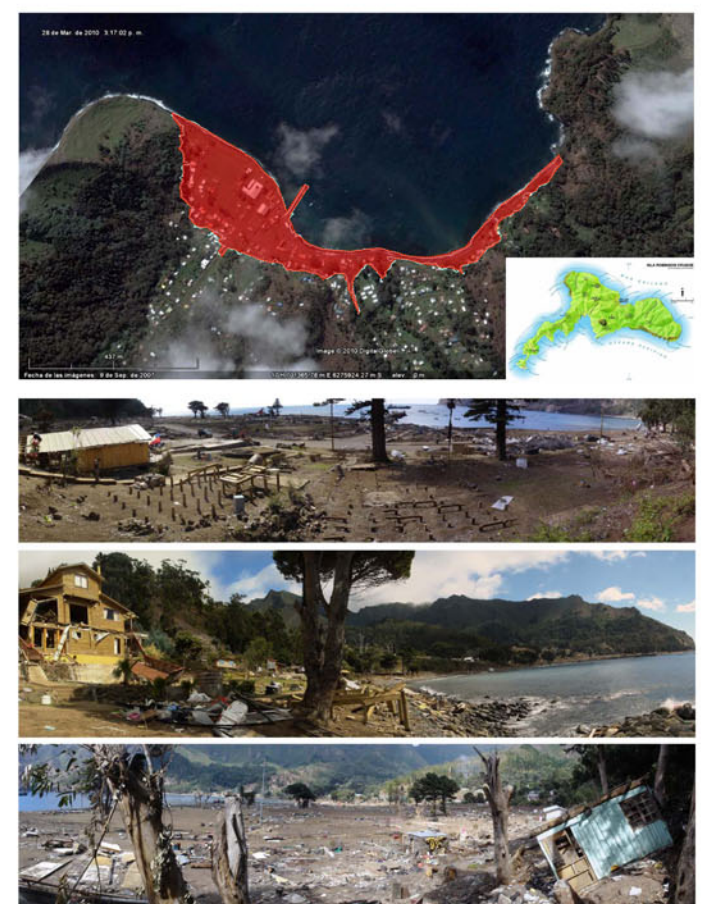
The Archipelago Juan Fernández is located 667 km off the coast of Chile due west of Valparaíso. The volcanic islands are sparsely populated with 600 inhabitants concentrated in the coastal town of San Juan Bautista situated in Cumberland Bay. The first tsunami wave impacted San Juan Bautista 49 minutes after the earthquake as a relatively slow moving flood comparable to a rapid high tide, followed by a violent wave which destroyed around 160 houses and the majority of public facilities. The lowlands of the coastal town were devastated, resulting in a death toll of 18 people. The ringing of the church bells by the 12 year old daughter of one of the local carabineros triggered an evacuation at the very last and contained the death toll. Two surveys were carried out on Robinson Crusoe Island on March 24 and from March 26 to 31, 2010. The field survey results highlight maximum runup of 20 m, flow depths up to 9 m, and maximum inundation of approximately 300 m (Figure 6).

Figure 6. Archipelago Juan Fernández: (a) Mapped inundation at San Juan Bautista, (b) Destruction along Cumberland Bay (credit: Patricio Winckler, Universidad de Valparaíso, Chile).

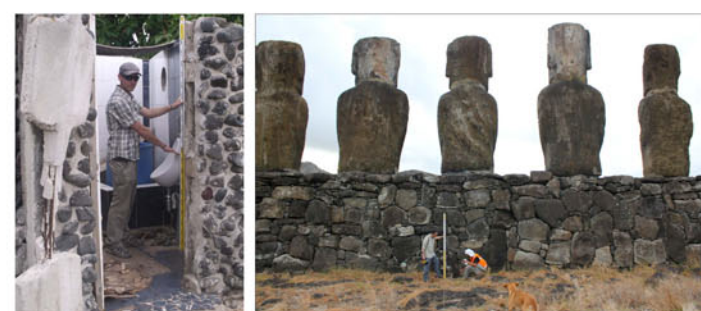
Rapa Nui is located 3500 km off the coast of continental Chile almost due west of Juan Fernández. Rapa Nui was surveyed from March 20 to 22, 2010. The field survey results highlight maximum runup of 4 m. At Tongariki the tsunami reached up to the ahu (stone platform) and flooded a nearby house (Figure 7).

Figure 7. Tongariki, Rapa Nui: (a) flooded house; (b) eyewitness indicates inundation limit at the ahu with the moai statues.
